PHOTOGRAPH LOG

Project Name: Gold King Mine	Site Location: Silverton, San Juan County, Colorado	Project No. 0001/1408-01
--	---	------------------------------------

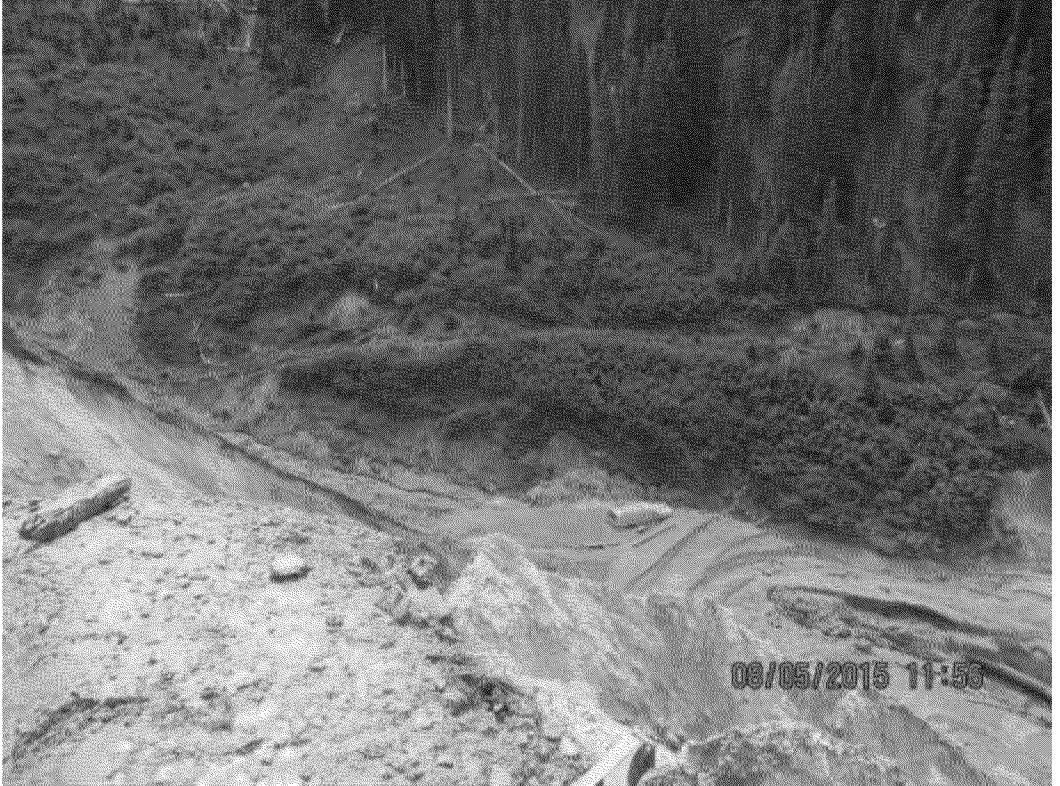
08/05/2015 11:55
Direction Photo Taken: Southeast/Down	Description: Collapsed portion of waste dump and road wash out.

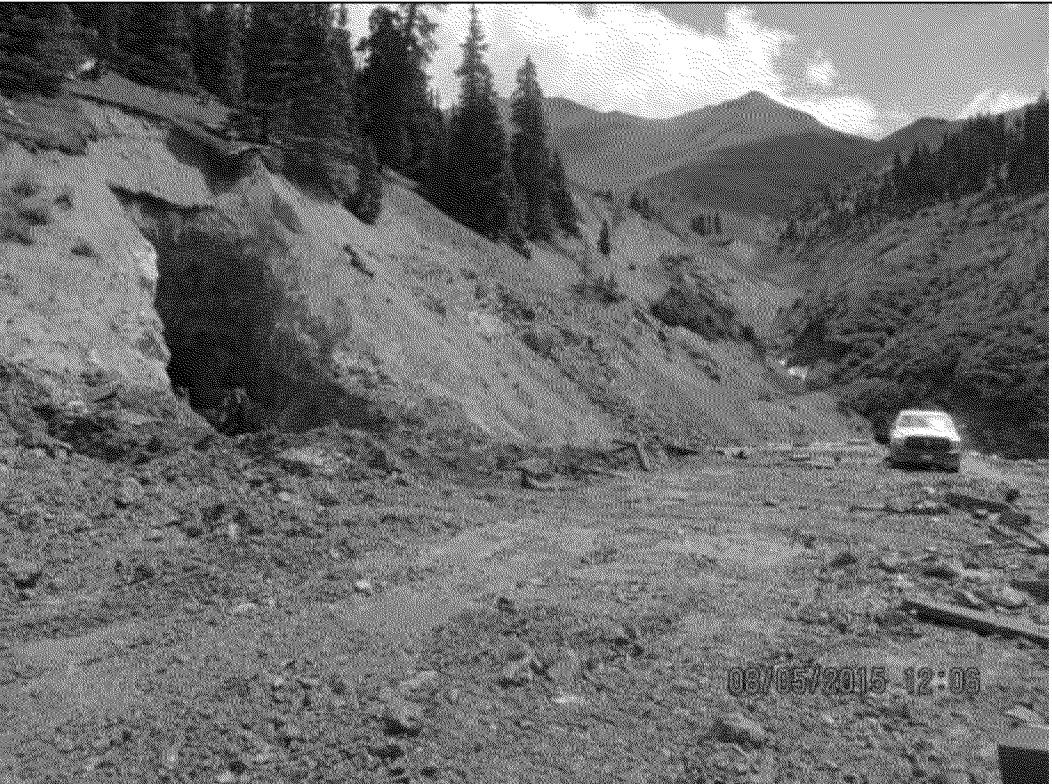
Description: Adit area after regrading.			
Photo No. 32	Date: 08/05/2015	Direction Photo Taken: North

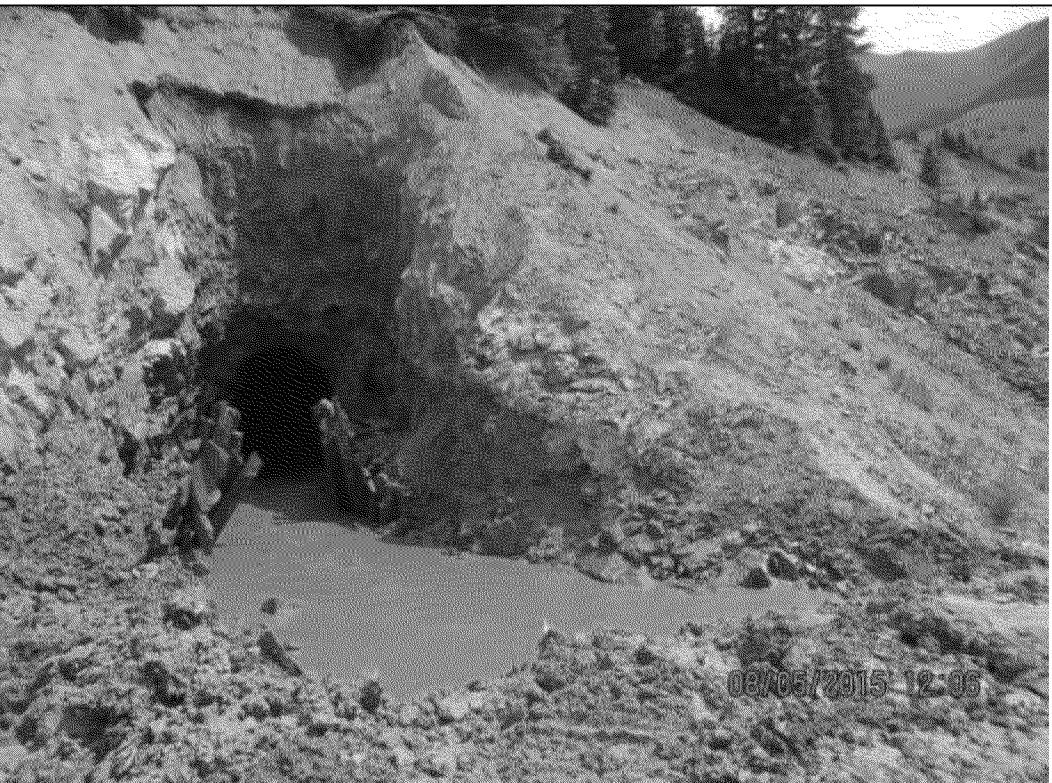
Description: Exposed adit and redirected flow, flow is beginning to subside.

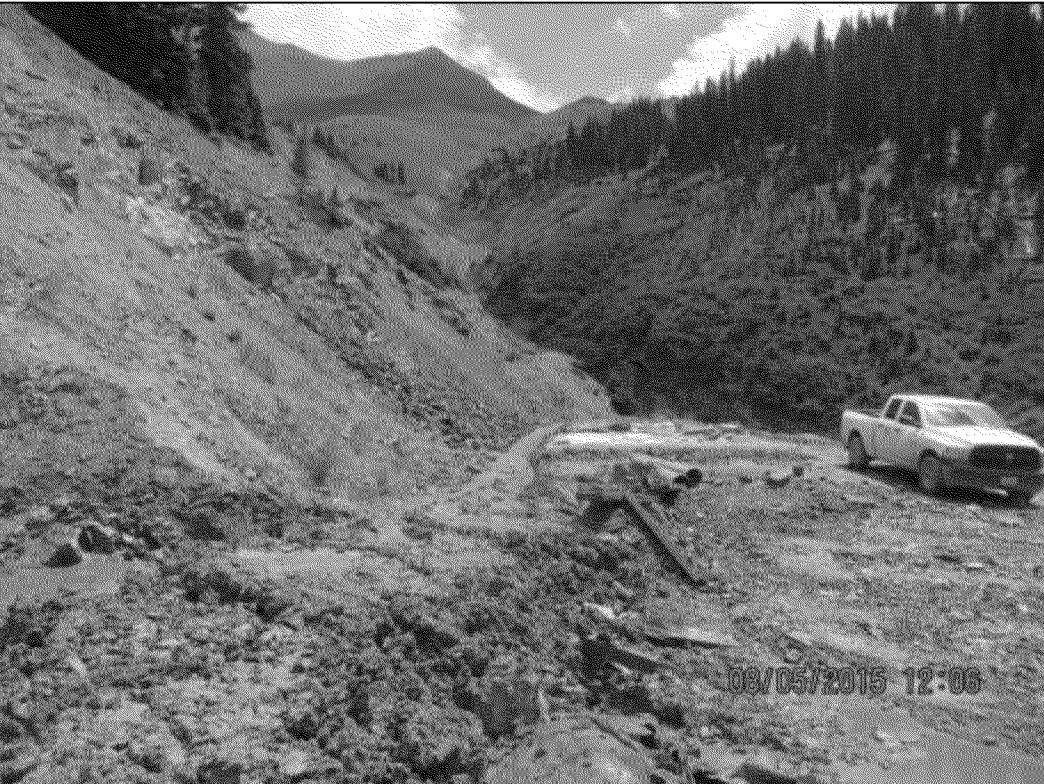
Direction Photo Taken:	East		
Description:	Redirected flow into existing half culvert channel.		
Photo No. 34	Date: 08/05/2015

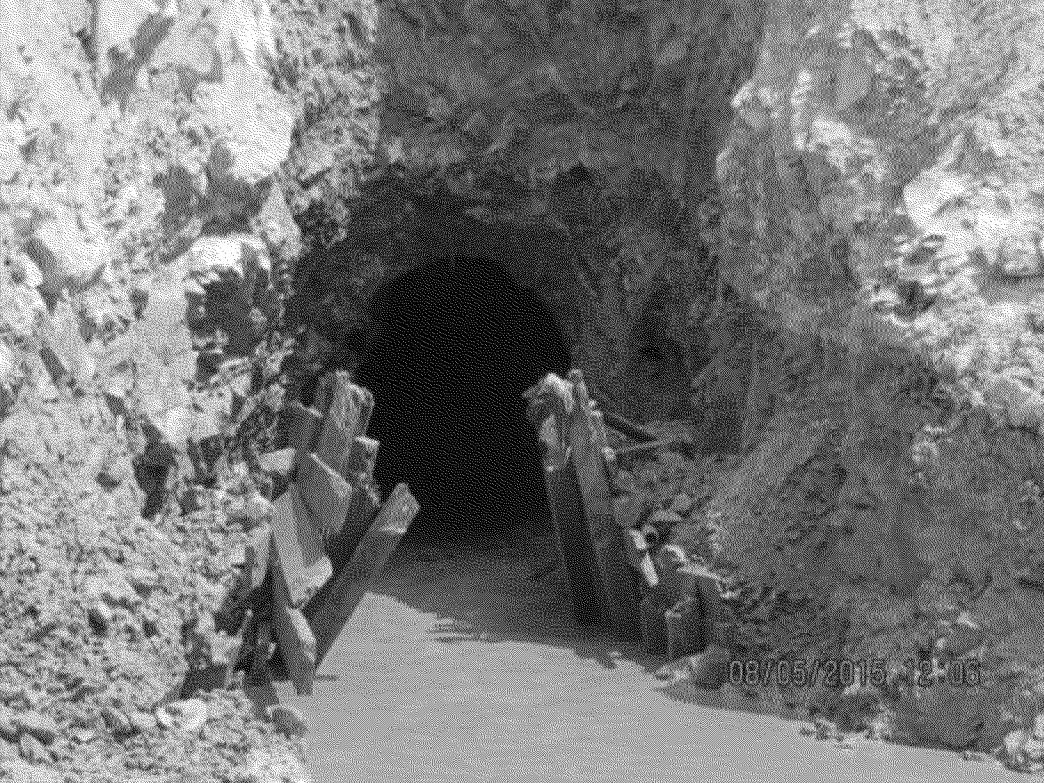
Direction Photo Taken:	North		
Description:	Closeup of adit.

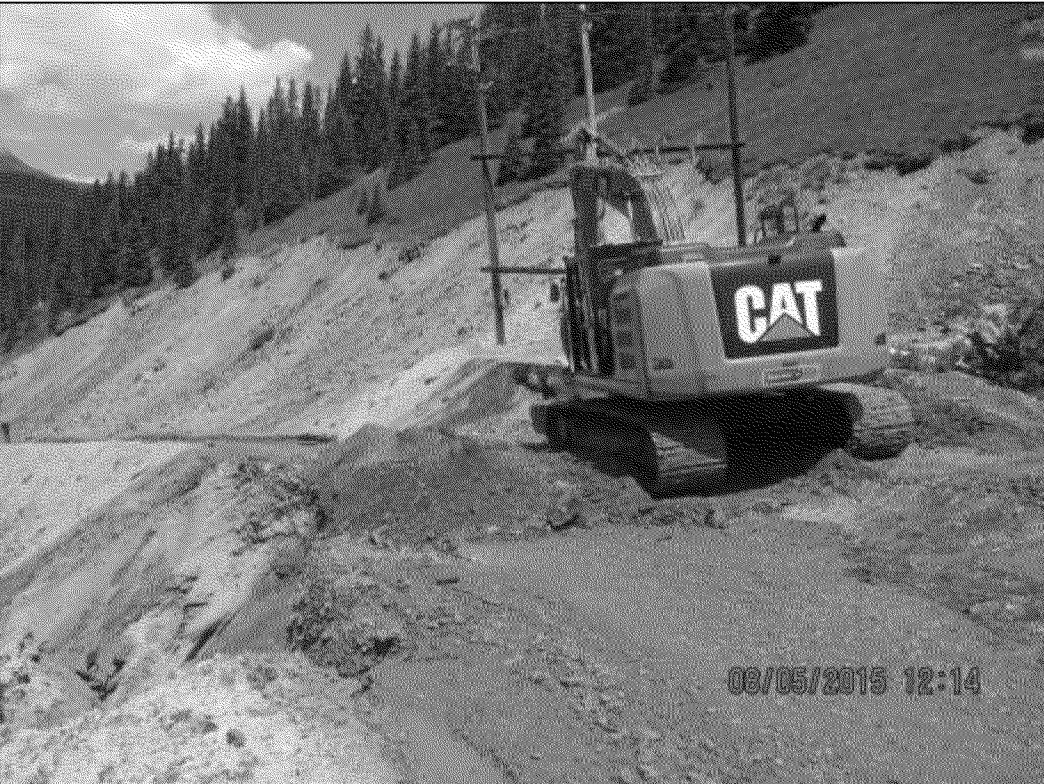
Description: Excavator beginning work to secure safe exit route for equipment, vehicles, and personnel.		
Photo No. 36	Date: 08/05/2015 Direction Photo Taken: East

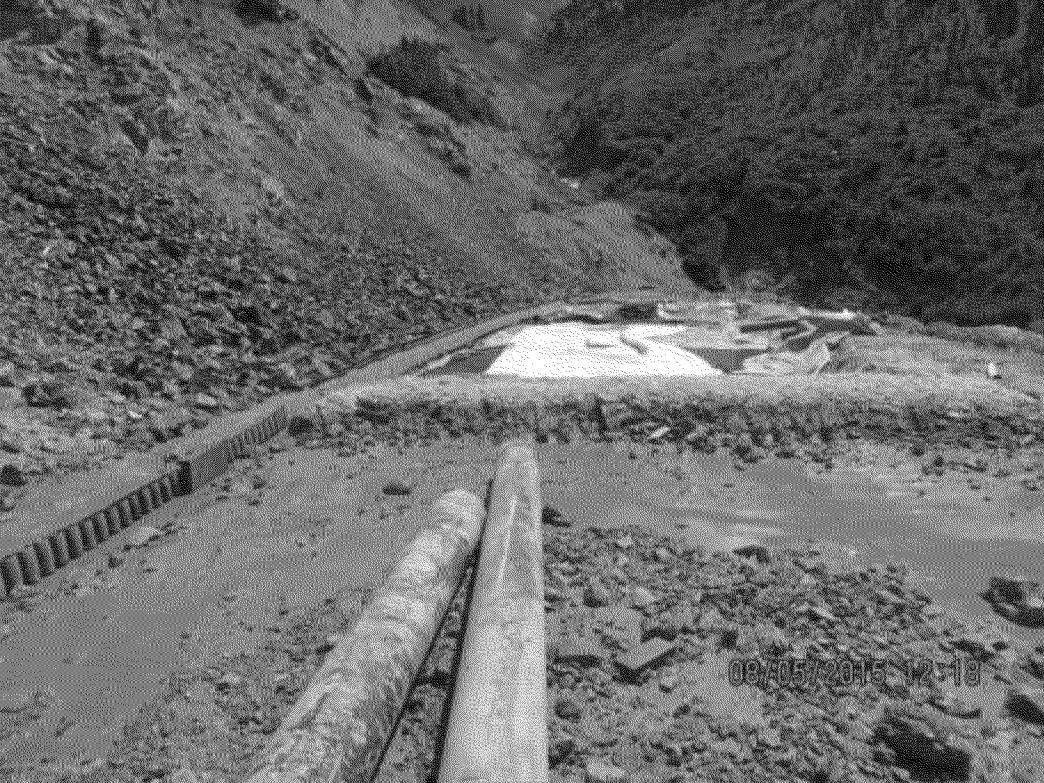
Description: Existing flow channel at maximum capacity.

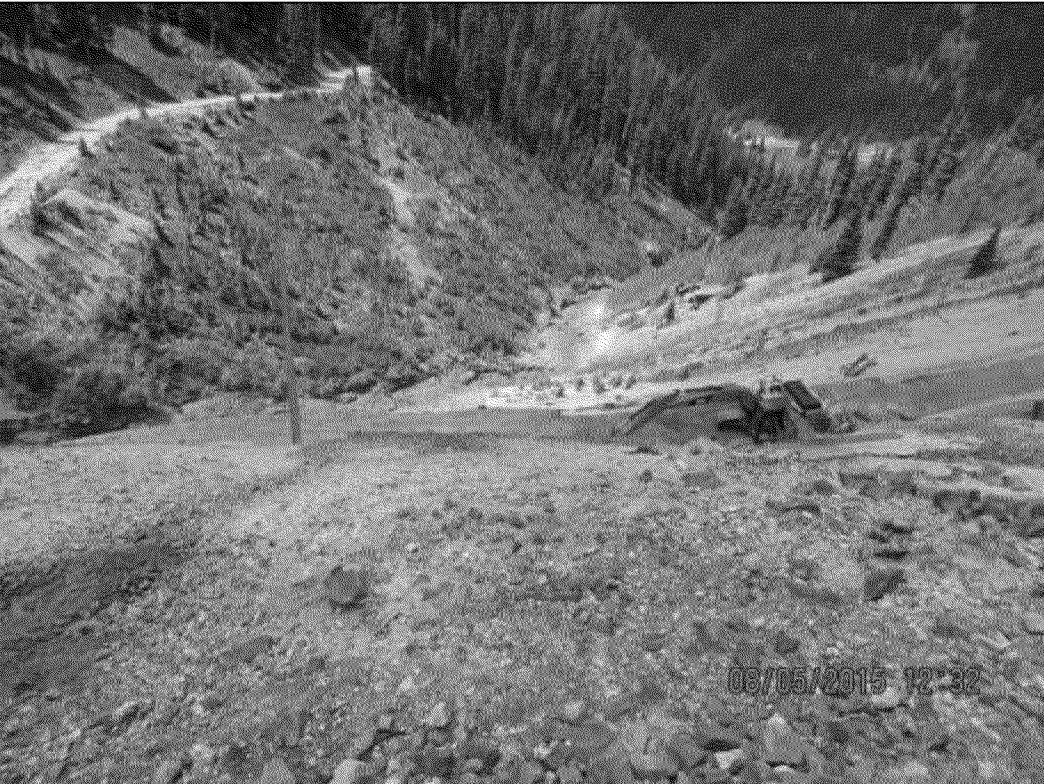
Direction Photo Taken:	Southwest/Down		
Description:	Excavator progress on fixing access road to create a safe exit route.		
Photo No. 38	Date: 08/05/2015

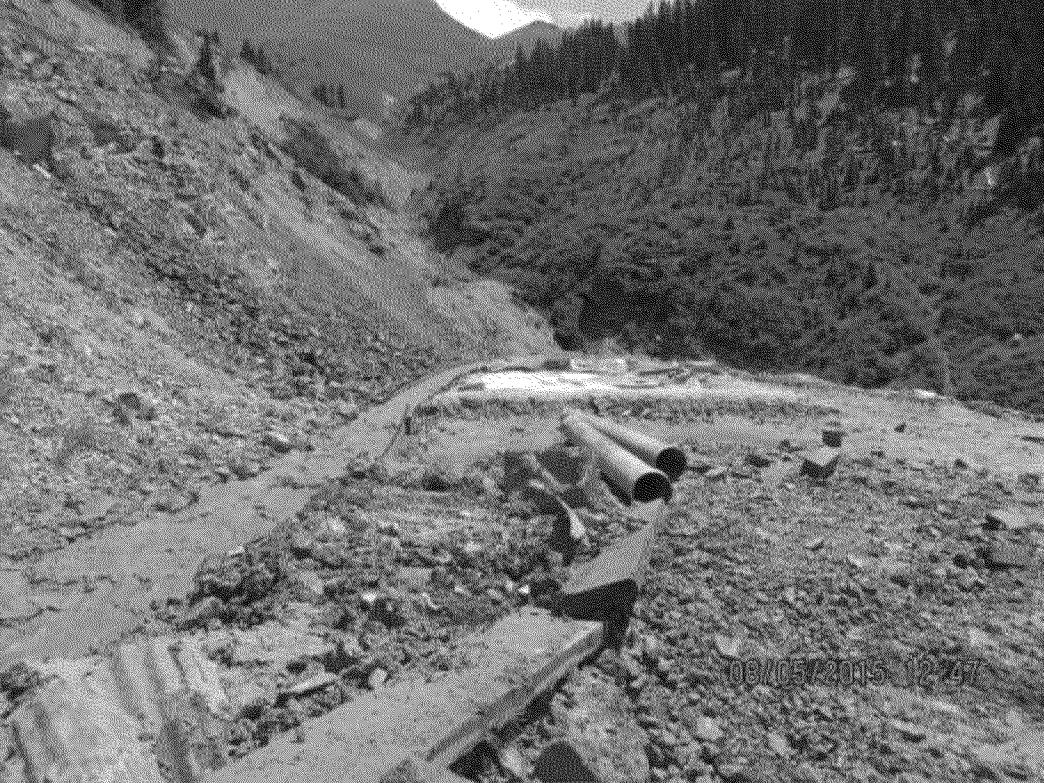
Direction Photo Taken:	East		
Description:	Existing culvert flows subsiding minimally.

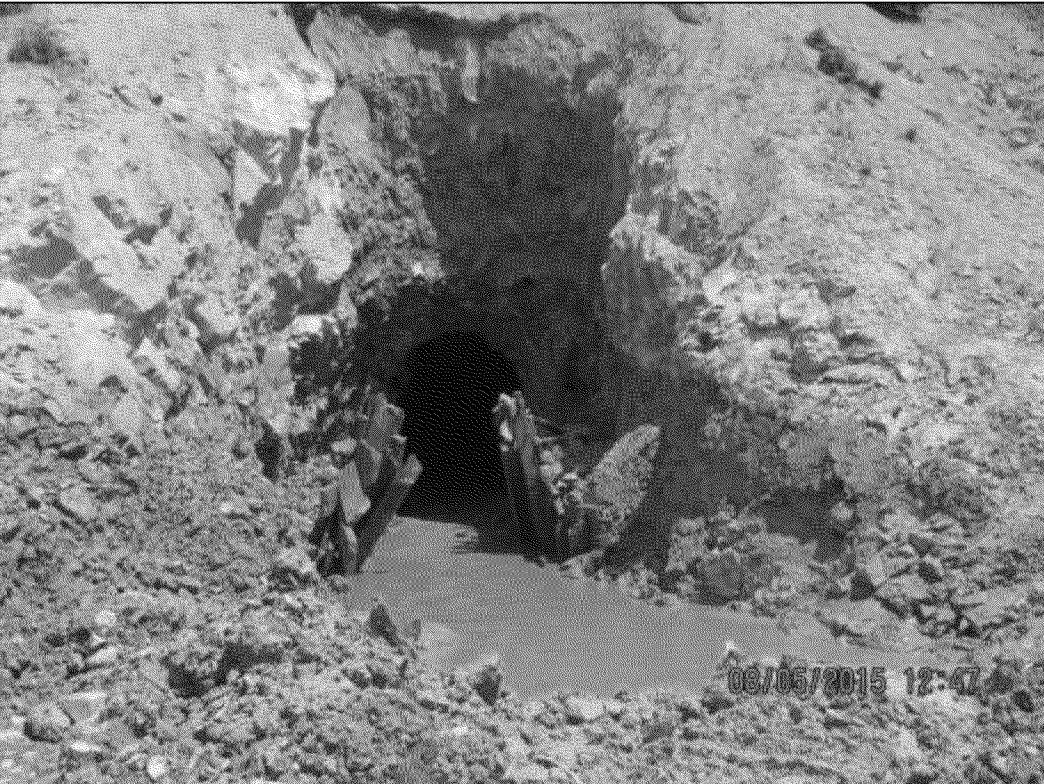
Description: No changes visible in adit structure or supports. Sloughing of materials inside the mine can be heard.			
Photo No. 40	Date: 08/05/2015	Direction Photo Taken: South/Down

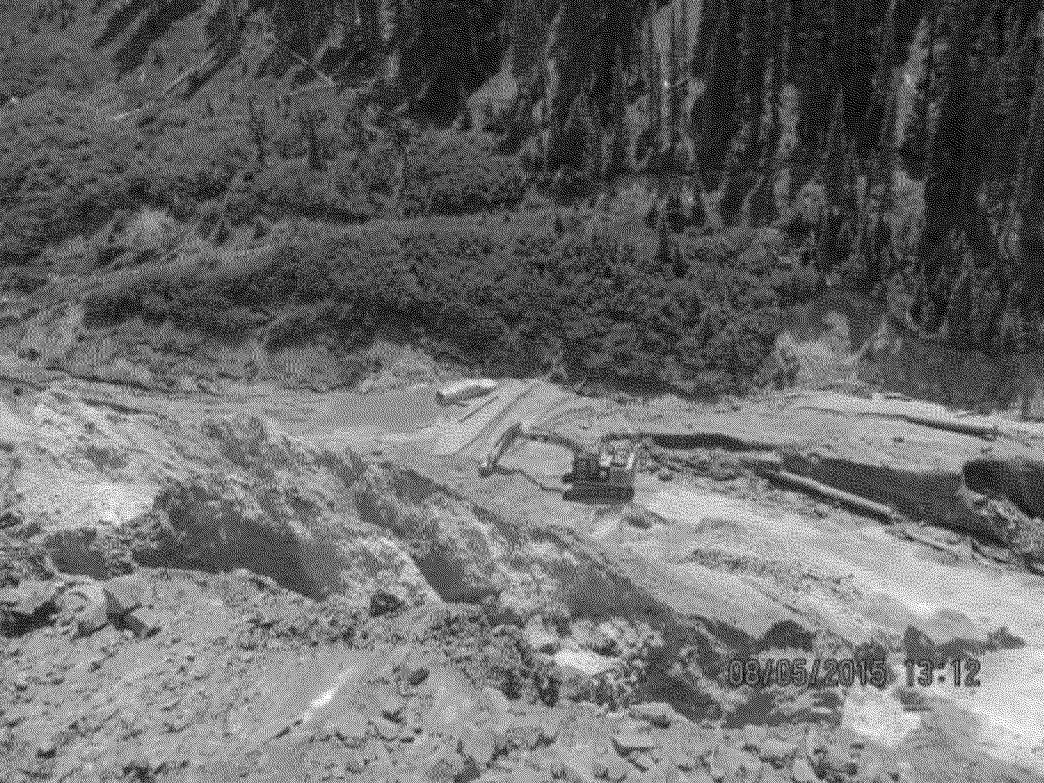
Description: Excavator progresses to washed out North Fork crossing.

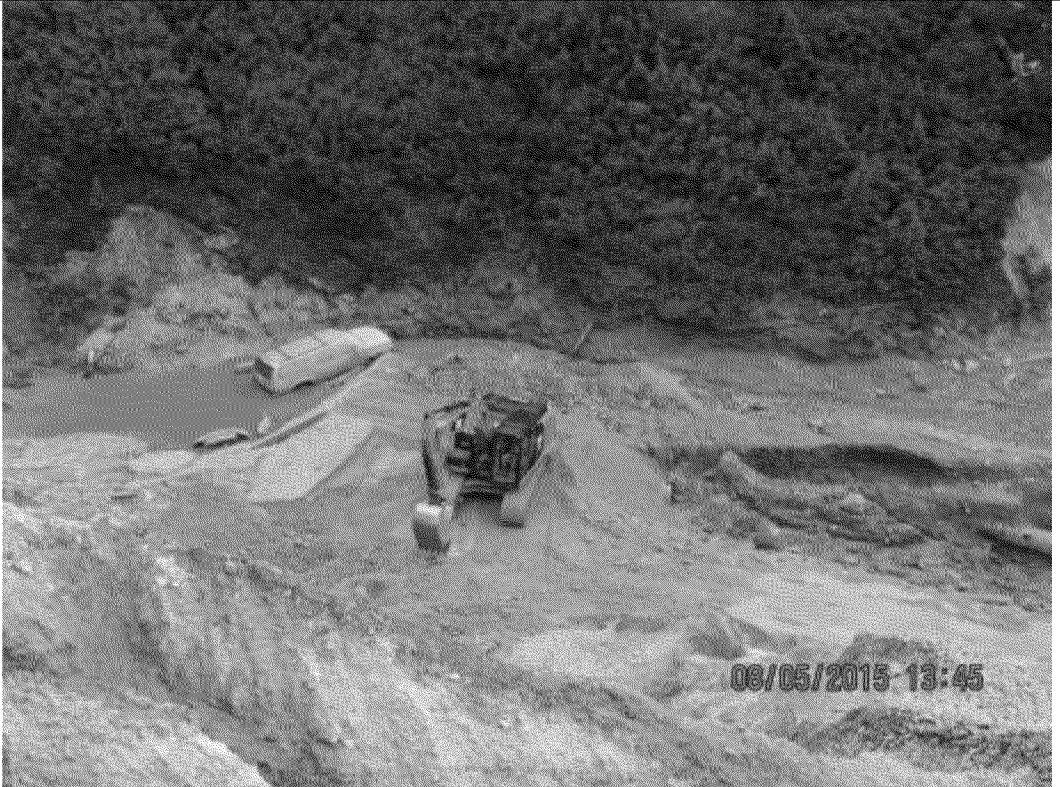
08/05/2015 13:45
Description: Excavator continues to fix access road. Continued high flow is slowing progress.			
Photo No. 44	Date: 08/05/2015	Direction Photo Taken: East

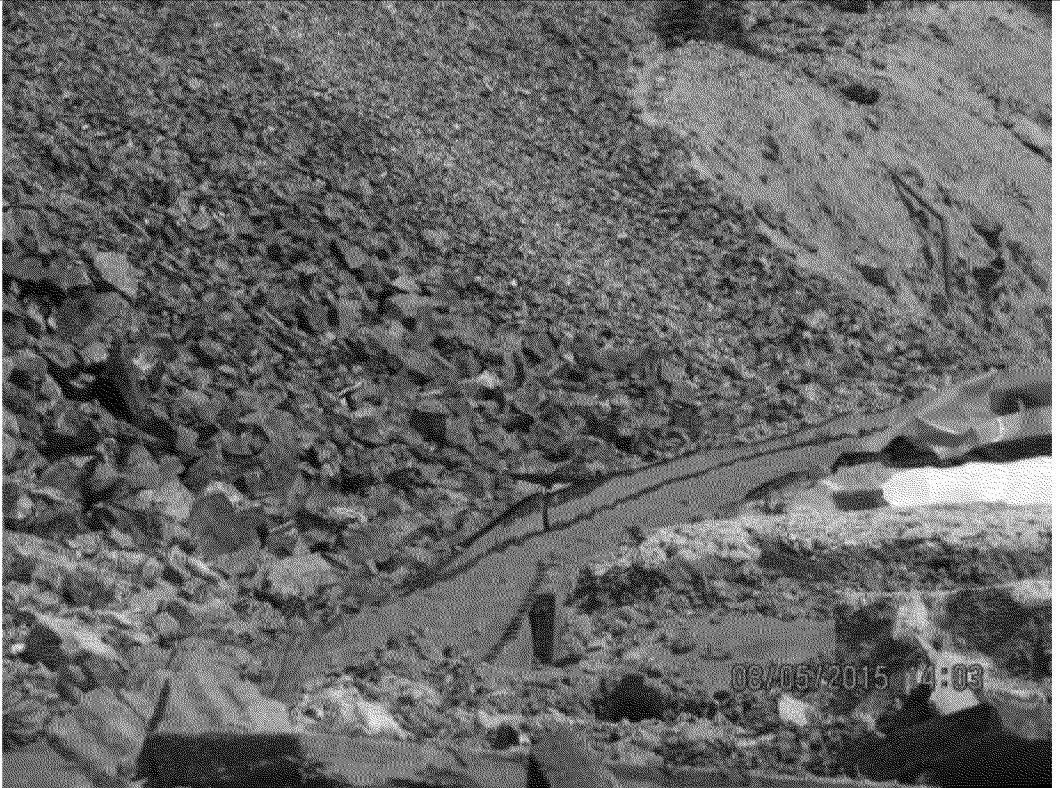
08/05/2015 14:03
Description: Half culvert flow continues to subside.

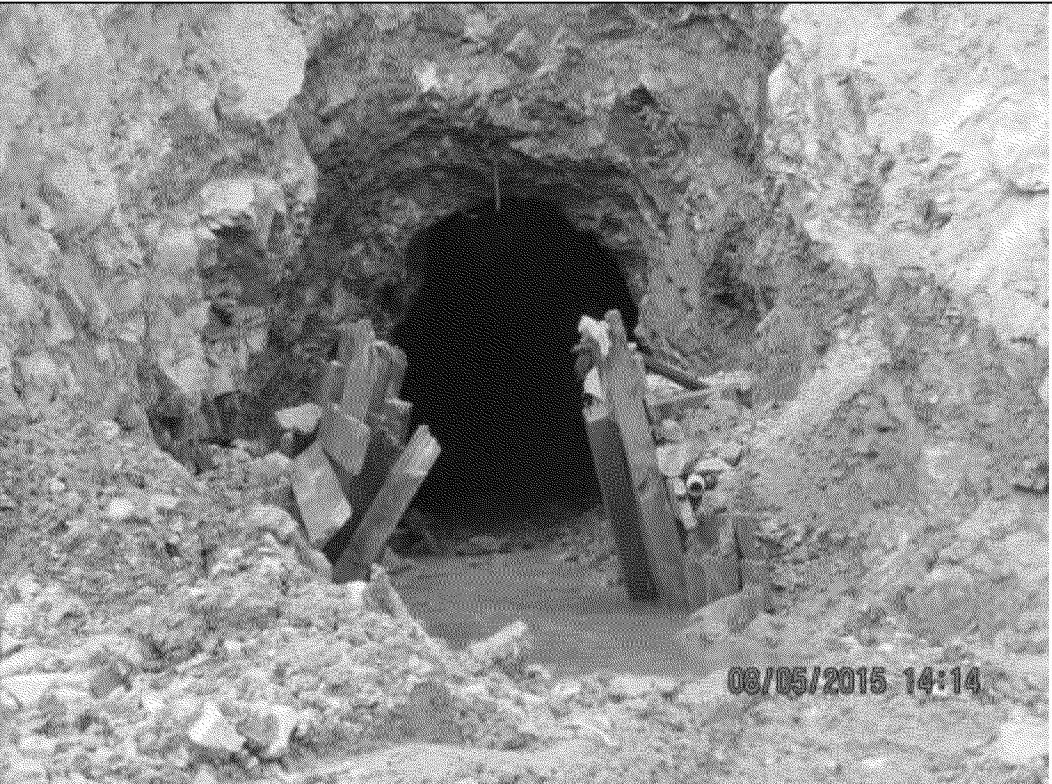
08/05/2015 14:14
Direction Photo Taken: North	Description: Water levels lowering at adit entrance, no visible changes to structure.

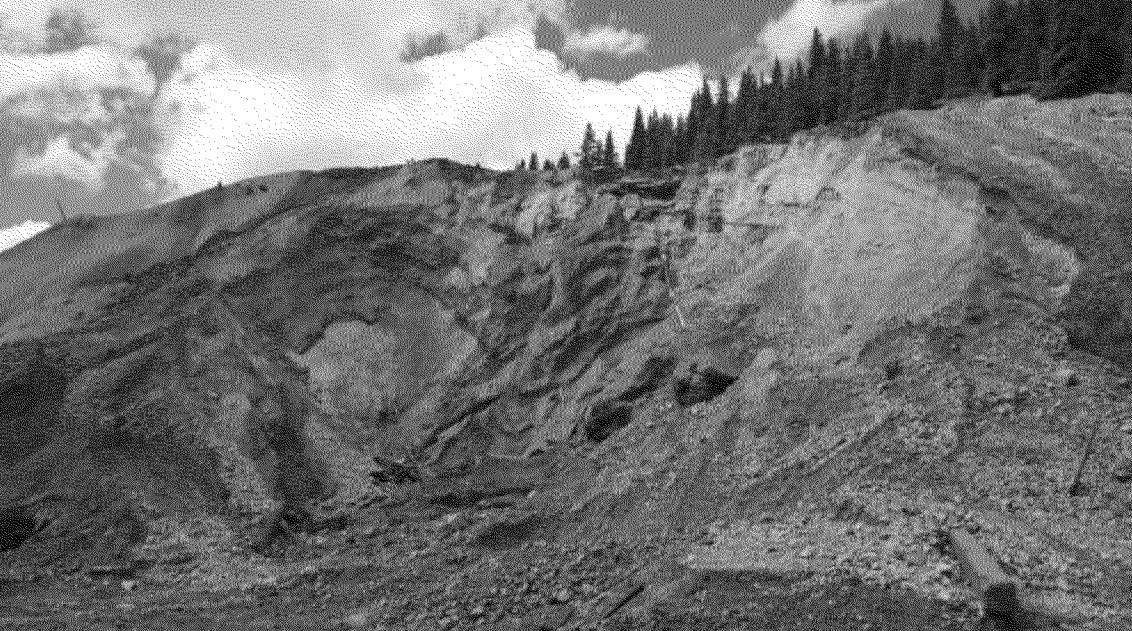
Description: Looking up from the toe of the Gold King waste dump directly south of the adit.		
Photo No. 52 Direction Photo Taken: Northeast	Date: 08/05/2015

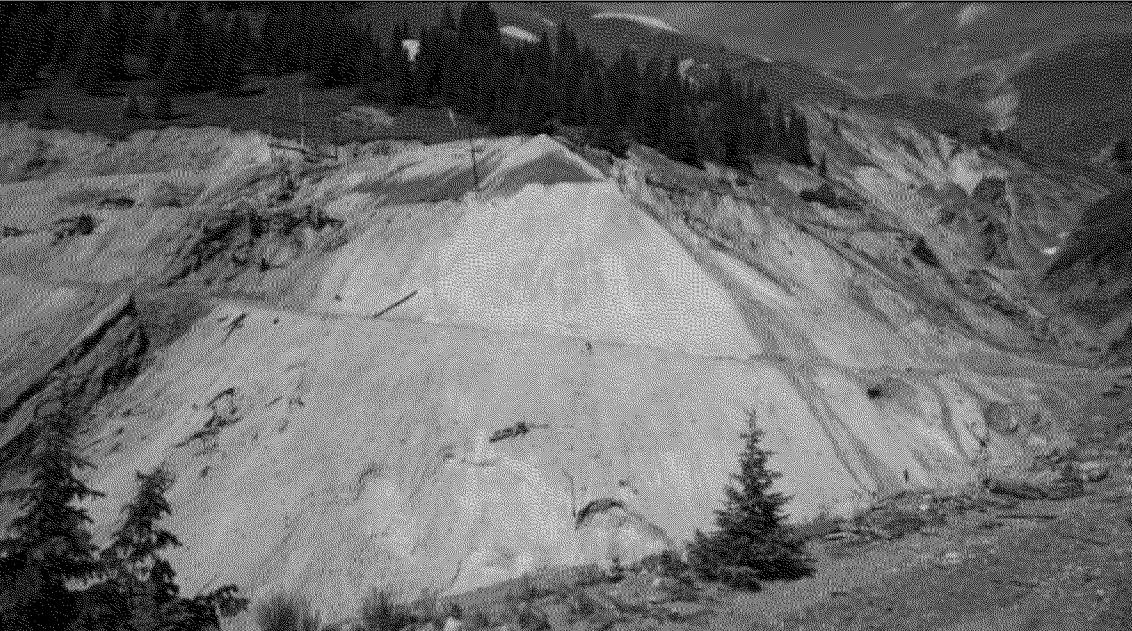
Description: Gold King Mine tailings dump after water discharge.
